AVIATION INVESTIGATION REPORT
A00P0090

LOSS OF SEPARATION

NAV CANADA
VANCOUVER AREA CONTROL CENTRE—WEST SECTOR
TOFINO, BRITISH COLUMBIA 17 NM E
30 MAY 2000

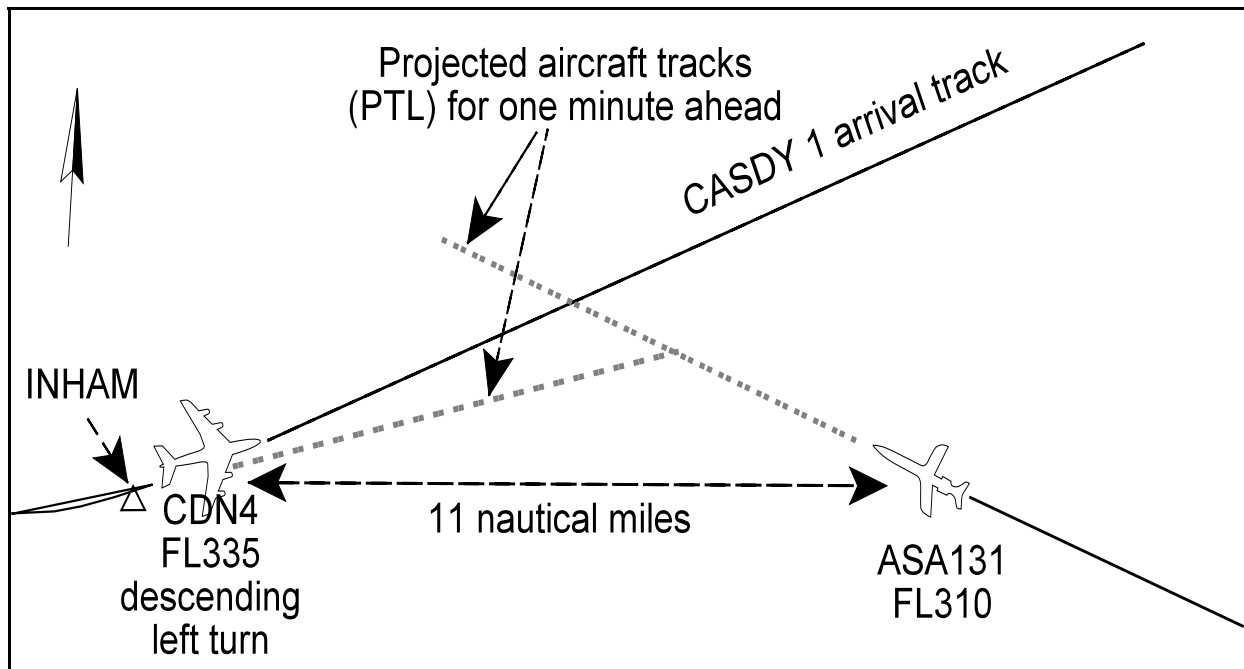
At 0940:00, CDN4 was cleared to descend from flight level (FL) 350 to 17 000 feet; the crew reported leaving FL350 at 0941:35. The descent clearance made no reference to ASA131. At 0942:27, CDN4 was near the INHAM intersection, in a descending left turn to intercept the CASDY ONE arrival track, when the crew sighted ASA131. (See Figure 1.) Shortly thereafter, the crew of CDN4 received a traffic alert and collision-avoidance system (TCAS) traffic advisory (TA), followed by a TCAS resolution advisory (RA) to climb. Because the intruder aircraft was in sight and there was no chance of collision, the captain of CDN4 chose not to comply with the TCAS RA and continued to descend. This decision is in accordance with the *Canadian Airlines Flight Operations Manual*. CDN4 then initiated contact with the west sector controller to advise him of the situation. At approximately the same time, the crew of ASA131 received a TCAS TA, visually confirmed that the descending Boeing 747 would cross behind their aircraft, and took no further action. Radar data indicate that, at 0943:20, CDN4 passed approximately 1 nautical mile behind and 700 feet above ASA131.

Figure 1 - Approximate position of CDN4 when ASA131 sighted
